**Flood Control Project Maintenance  
Levee Inspections**  
**LMA District Cover Sheet**  
**Spring 2017 Levee Inspection Results**

**Sacramento River West Side Levee District**

| Waterway | | | Bank | Unit Miles |
|--|---|---|---|---|
| Unit No. 01 Sacramento River | | | Right | 49.64 |

**Levee Inspection Report By Mile - Spring 2017**

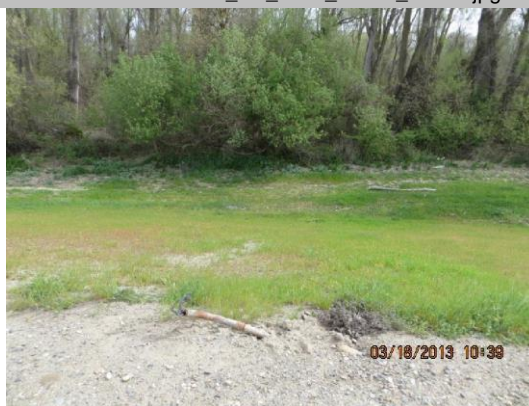
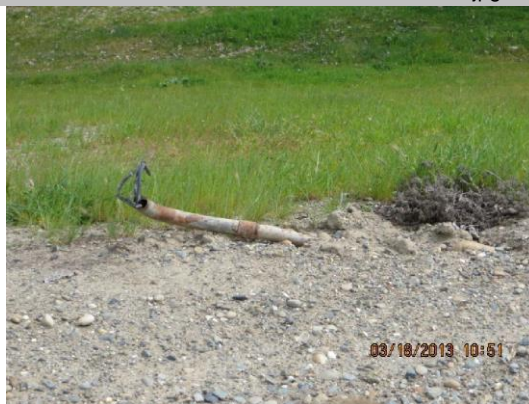
Photo 1 of 2 : UCIP\_SP\_2017\_10425\_17702.jpg

| FS_ID:10425<br>DS_ID:20398<br>EP_NO: 9364<br>Repair Type: Non-Urgent<br>Crossing Status: Found<br>UCIP Comments: Remove abandoned pipe from levee.<br>FIELD_STRUCT_DESC: 4 of 4: *Abandoned* 1.25-inch conduit through<br>levee 3.0 feet below crown (ABO No. 9364A).<br>FS Date: 3/18/2013 | | | | | |

Electrical conduit on WS shoulder.

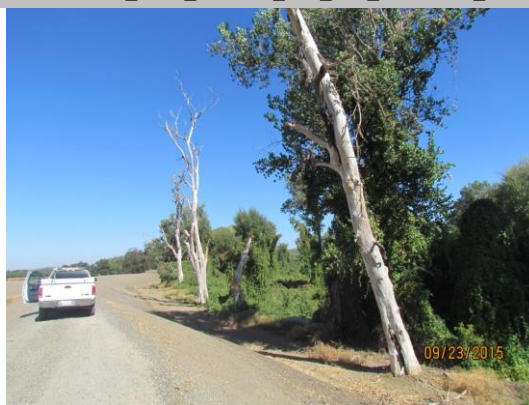
Photo 1 of 1 : SP\_2017\_NA0016\_435\_139\_20170320\_00071.jpg

View of the dying tree on the waterward side of the levee looking upstream. Fall 2015.

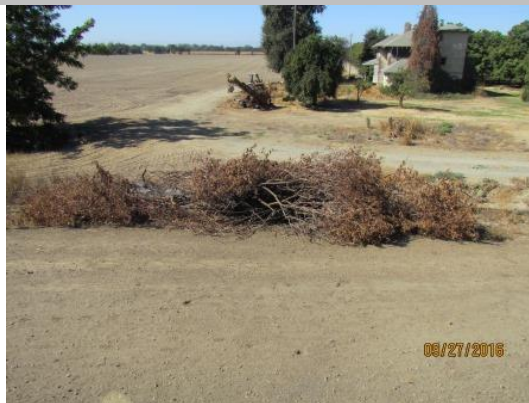
Photo 1 of 1 : SP\_2017\_NA0016\_435\_91\_20170320\_00043.jpg

Tree prunings on landside slope. Fall 2016 inspection.

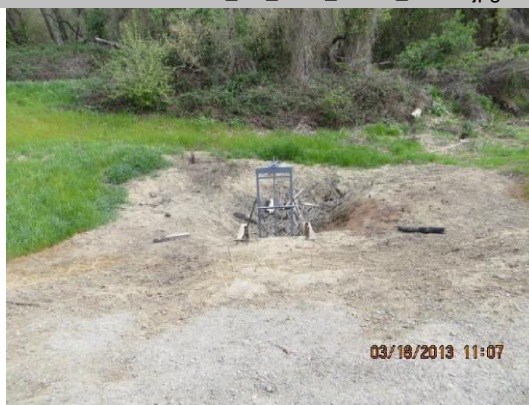
Photo 1 of 3 : UCIP\_SP\_2017\_10426\_17705.jpg

| FS_ID:10426<br>DS_ID:20345<br>EP_NO: 9374<br>Repair Type: Non-Urgent<br>Crossing Status: Found<br>UCIP Comments: Verify if pipe is abandoned with landowner and remove or abandon properly if necessary.<br>FIELD_STRUCT_DESC: *ABANDONED* 3 of 3: 24-inch concrete encased steel drain pipe through levee 17.0 feet below crown. Slide gate on concrete headwalls in waterward end, walkway to control gate and gate valve on landward end (ABO No. 9374, 1960). Originally included in the 1960 O&M manual.<br>FS Date: 3/18/2013 | | | | | |

Slide gate on WS toe.

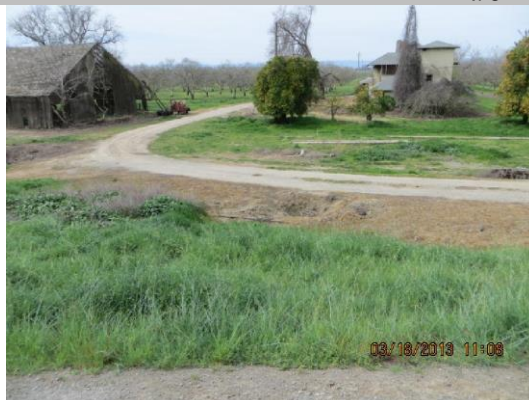
Photo 2 of 3 : UCIP\_SP\_2017\_10426\_17704.jpg

Headwall and gate valve on LS toe buried but partially exposed.

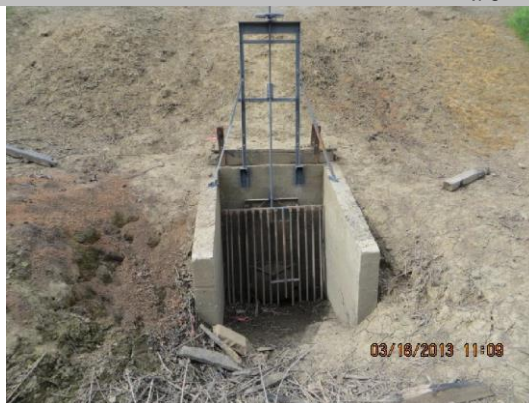
Photo 3 of 3 : UCIP\_SP\_2017\_10426\_17703.jpg

Outlet/inlet on WS toe.

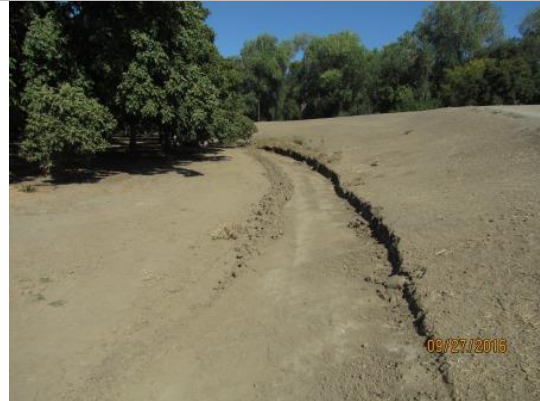
Photo 1 of 1 : SP\_2017\_NA0016\_435\_94\_20170320\_00044.jpg

Levee toe on landward side has been cut due to agricultural work. Fall 2016 inspection.

| LMA contacted the property owner to eliminate this issue. LMA may provide pictures of this site after issue is corrected. | | | | | |

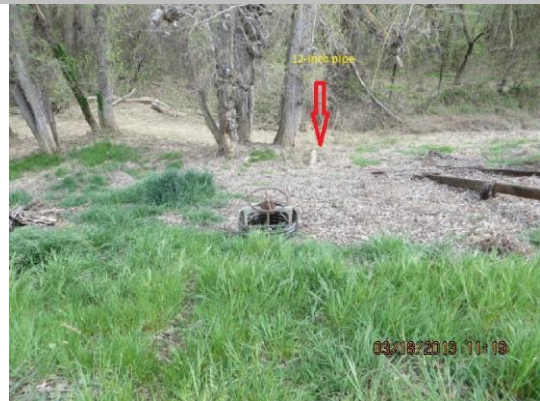
Photo 1 of 3 : UCIP\_SP\_2017\_10444\_17725.jpg

| FS_ID:10444<br>DS_ID:20274<br>EP_NO: 9374<br>Repair Type: Non-Urgent<br>Crossing Status: Found<br>UCIP Comments: Pipe should be abandoned properly.<br>FIELD_STRUCT_DESC: 4 of 4: 24-inch corrugated metal pipe through levee 15.5 feet below crown (ABO No. 9374, 1974). Two corrugated metal cutoff walls. Slide gate in 36-inch corrugated metal riser unit on the waterward slope. Pump house with no connection on waterward bank. 12-inch steel pipe with steel plate over end at WS toe (likely pump connection point). 6-foot diameter concrete riser on LS toe. Skid rails mounted on wood piling on the waterward slope. Department of Water Resources B.M. SR 47 on top of concrete anchor post on the waterward shoulder. Power pole and meter box on the waterward shoulder. Switch panel in metal house on the waterward slope. Concrete standpipe on the landward side. Overhead power line crosses the levee to service pole.<br>FS Date: 3/18/2013 7:51:00 AM | | | | | |

36-inch CMP riser with slide gate on WS slope with 12-inch pipe at Toe.

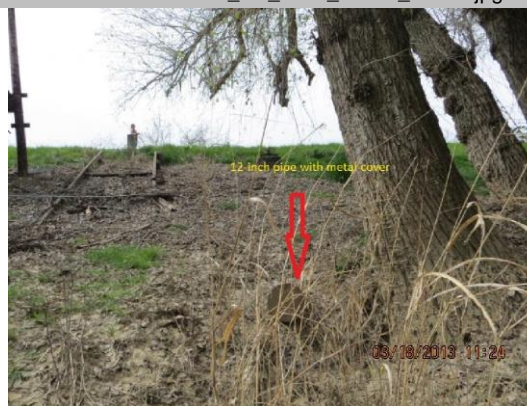
Photo 2 of 3 : UCIP\_SP\_2017\_10444\_17724.jpg

Wooden ramp and 2-inch pump connection at WS toe.

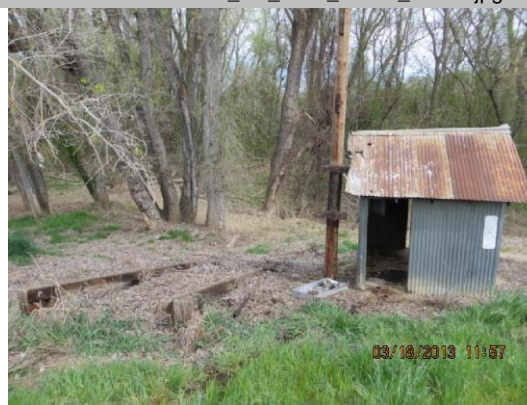
Photo 3 of 3 : UCIP\_SP\_2017\_10444\_17723.jpg

Pump house, JP, and wooden ramp on WS slope.

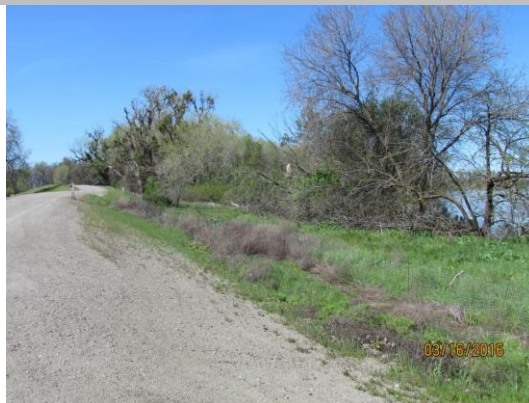
Photo 1 of 2 : SP\_2017\_NA0016\_435\_33\_20170320\_00027.jpg

| Revegetation site is fenced off. | | | | | |

View of the revegetation site on the waterward berm of the levee looking upstream. Spring 2016.

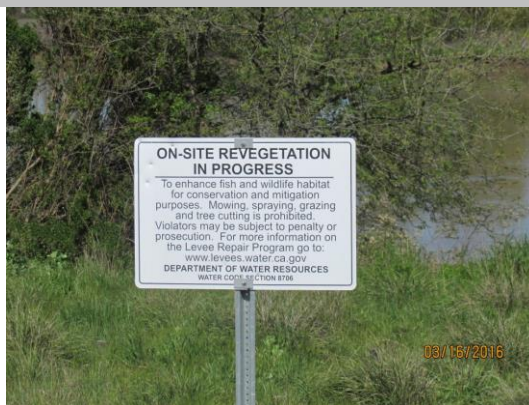
Photo 2 of 2 : SP\_2017\_NA0016\_435\_33\_20170320\_00028.jpg

Sign stating the revegetation site. Spring 2016.

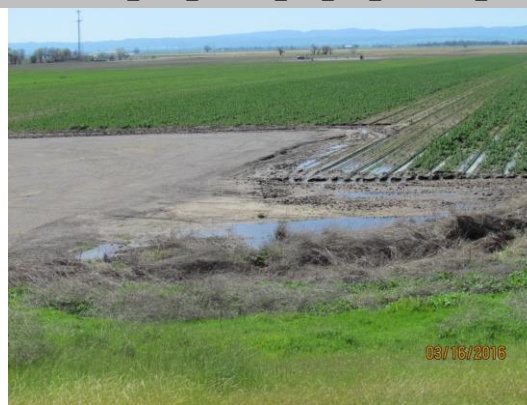
Photo 1 of 1 : SP\_2017\_NA0016\_435\_216\_20170320\_00107.jpg

View of the seepage on the landward side of the levee. Spring 2016.

| LMA is monitoring the seepage. | | | | | |

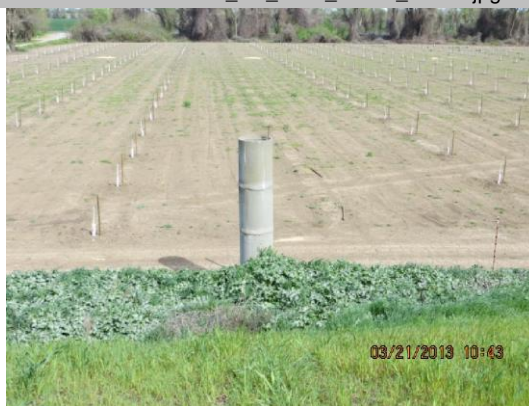
Photo 1 of 3 : UCIP\_SP\_2017\_10528\_17854.jpg

Concrete standpipe at LS toe.

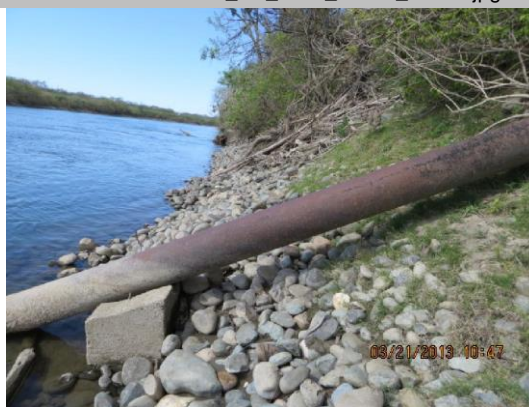
Photo 2 of 3 : UCIP\_SP\_2017\_10528\_17853.jpg

Pipe visible at WS toe.

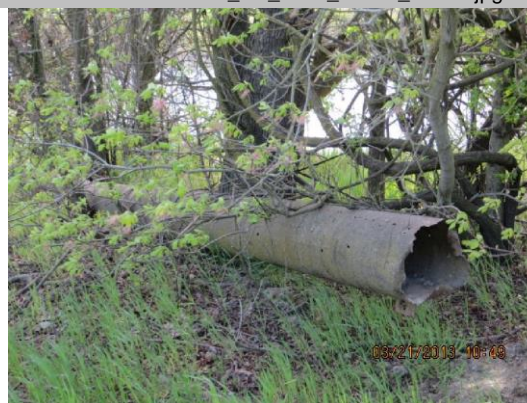
Photo 3 of 3 : UCIP\_SP\_2017\_10528\_17852.jpg

| FS_ID:10528<br>DS_ID:20282<br>EP_NO: 9352<br>Repair Type: Non-Urgent<br>Crossing Status: Found<br>UCIP Comments: Pipe appears to have been removed from levee section. Need to verify pipe abandonment.<br>FIELD_STRUCT_DESC: 12-inch steel pipe through levee 5.0 feet below crown. Switch house on waterward shoulder, pump and gate valve on waterward bank. Concrete discharge standpipe on landward side. Permit was for a 14-inch (Permit No. 635, 1935 ). Included in the 1960 O&M manual and ABO No. 9351.<br>FS Date: 3/21/2013 | | | | | |

12-inch pipe debris on WS berm.

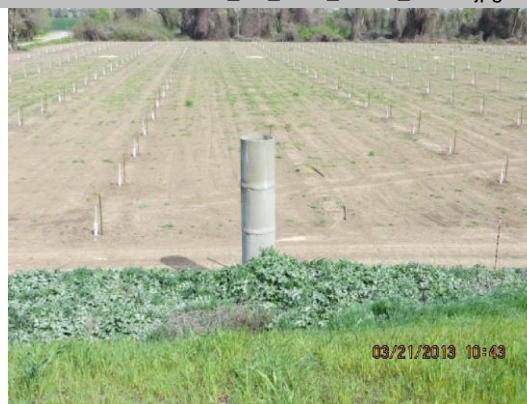
Photo 1 of 2 : UCIP\_SP\_2017\_11343\_18741.jpg

| FS_ID:11343<br>DS_ID:22966<br>EP_NO: 9352<br>Repair Type: Non-Urgent<br>Crossing Status: Found<br>UCIP Comments: Pipe should be removed.<br>FIELD_STRUCT_DESC: 1.5-inch galvanized iron electrical conduit through the levee at unknown depth. Visible on WS slope (Permit No. 635, 1935).<br>FS Date: 3/21/2013 | | | | | |

Electrical conduit approximately perpendicular to concrete riser on LS toe.

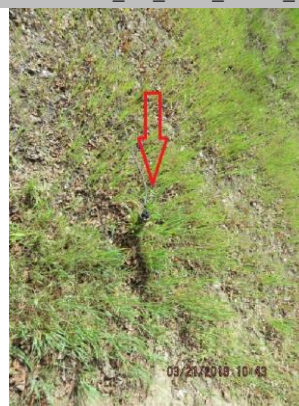
Photo 2 of 2 : UCIP\_SP\_2017\_11343\_18740.jpg

| FS_ID:11343<br>DS_ID:22966<br>EP_NO: 9352<br>Repair Type: Non-Urgent<br>Crossing Status: Found<br>UCIP Comments: Pipe should be removed.<br>FIELD_STRUCT_DESC: 1.5-inch galvanized iron electrical conduit through the levee at unknown depth. Visible on WS slope (Permit No. 635, 1935).<br>FS Date: 3/21/2013 | | | | | |

1.5-inch electrical conduit on WS slope.

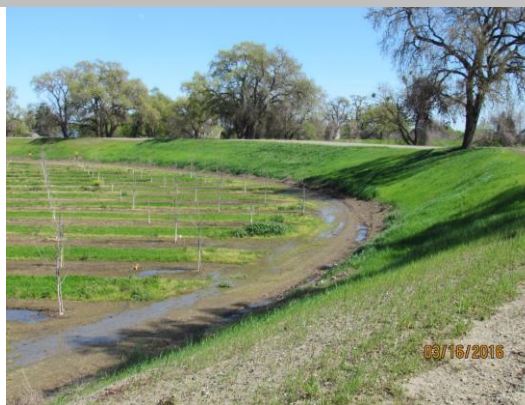
Photo 1 of 1 : SP\_2017\_NA0016\_435\_220\_20170320\_00108.jpg

View of the seepage on the landward side of the levee looking upstream. Spring 2016.

| LMA is monitoring seepage site. | | | | | |

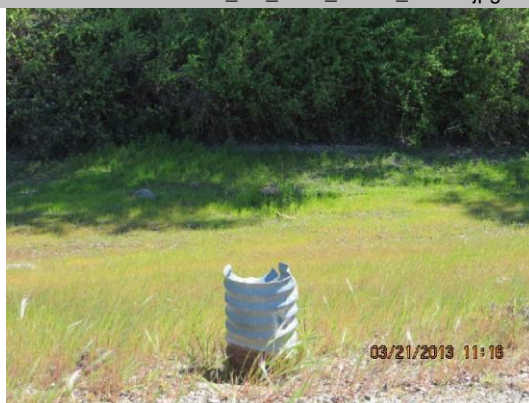
Photo 1 of 3 : UCIP\_SP\_2017\_10527\_17850.jpg

Vent in 12-inch CMP riser on WS shoulder.

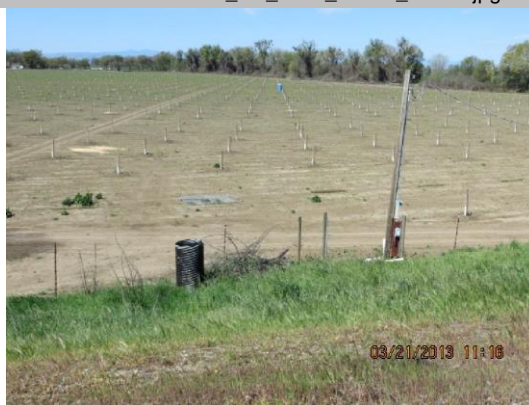
Photo 2 of 3 : UCIP\_SP\_2017\_10527\_17849.jpg

30-inch CMP riser with slide gate at LS toe.

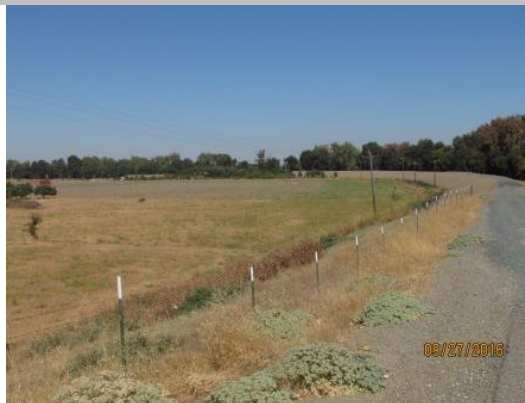
Photo 1 of 1 : SP\_2017\_NA0016\_435\_102\_20170320\_00051.jpg

View of owner's fence on landside. Fall 2016 inspection.

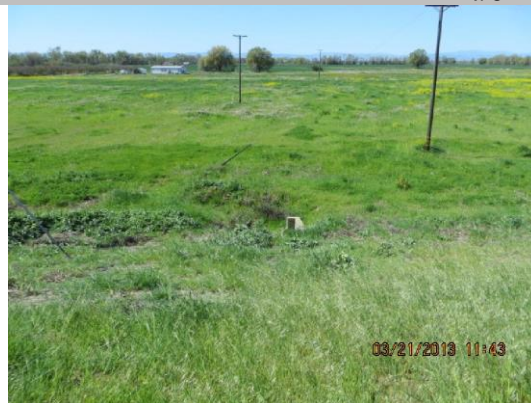
Photo 1 of 3 : UCIP\_SP\_2017\_10533\_17865.jpg

Demolished concrete distribution box at LS toe.

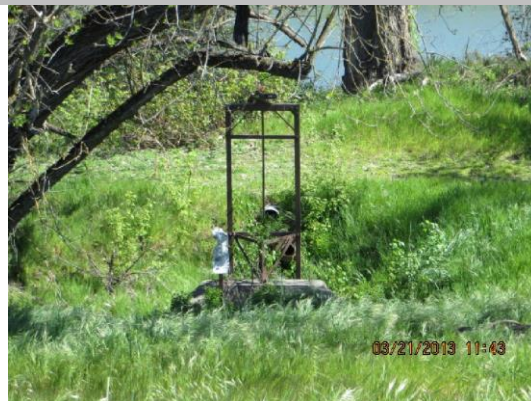
Photo 2 of 3 : UCIP\_SP\_2017\_10533\_17864.jpg

Slide gate at WS toe.

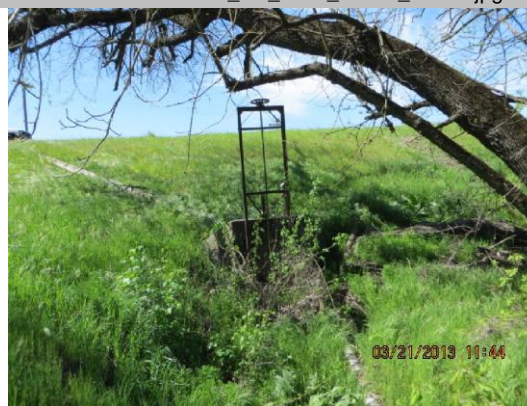
Photo 3 of 3 : UCIP\_SP\_2017\_10533\_17863.jpg

| FS_ID:10533<br>DS_ID:20287<br>EP_NO: 9351<br>Repair Type: Non-Urgent<br>Crossing Status: Found<br>UCIP Comments: Appears abandoned. Should be abandoned properly.<br>FIELD_STRUCT_DESC: 30-inch corrugated metal pipe through levee 17.5 feet below crown. Slide gate on the waterward end. Discharges into concrete box at the landward toe (ABO No. 9351, 1960). Small pump discharges into sump area in front of slide gate at WS toe.<br>FS Date: 3/21/2013 | | | | | |

Slide gate at WS toe.

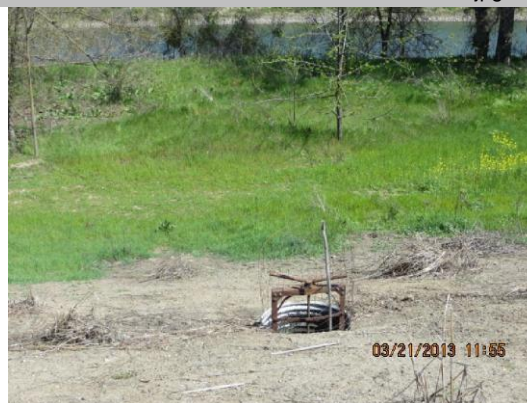
Photo 1 of 3 : UCIP\_SP\_2017\_10535\_17877.jpg

Slide gate in CMP riser on WS slope.

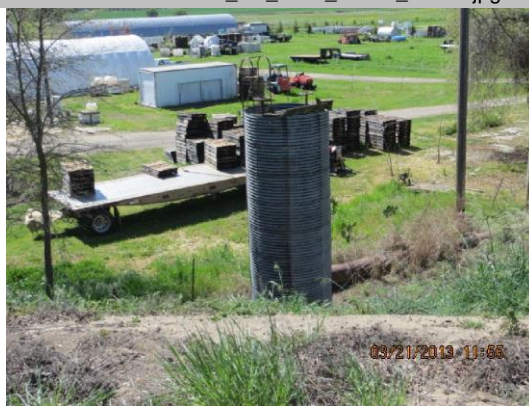
Photo 2 of 3 : UCIP\_SP\_2017\_10535\_17876.jpg

6-foot diameter CMP riser with slide gates on LS toe.

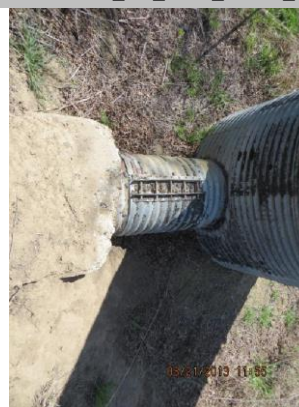
Photo 3 of 3 : UCIP\_SP\_2017\_10535\_17875.jpg

24-inch CMP at connection to CMP riser on LS toe.

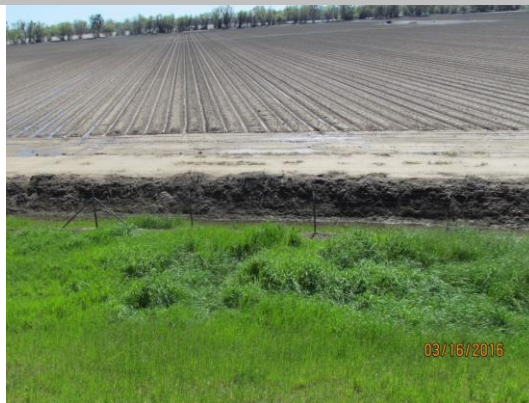
Photo 1 of 1 : SP\_2017\_NA0016\_435\_222\_20170320\_00109.jpg

| Seepage is being monitored by LMA. | | | | | |

View of the seepage in the ditch at the toe of the levee on the landward side. Spring 2016.

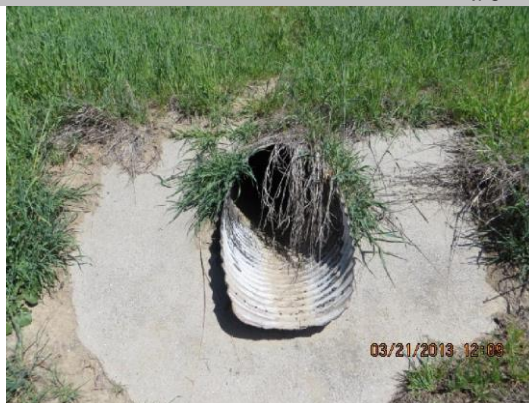
Photo 1 of 3 : UCIP\_SP\_2017\_10536\_17883.jpg

30-inch CMP at outlet on LS toe.

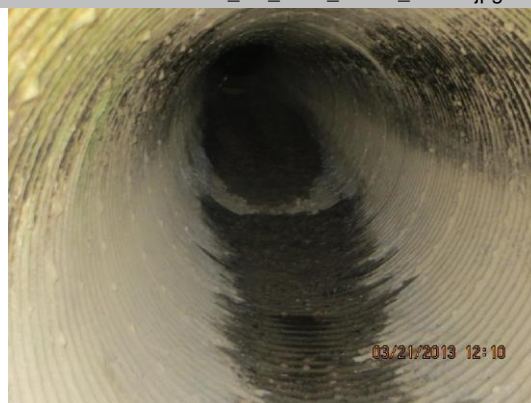
Photo 2 of 3 : UCIP\_SP\_2017\_10536\_17882.jpg

View from LS toe of CMP pipe.

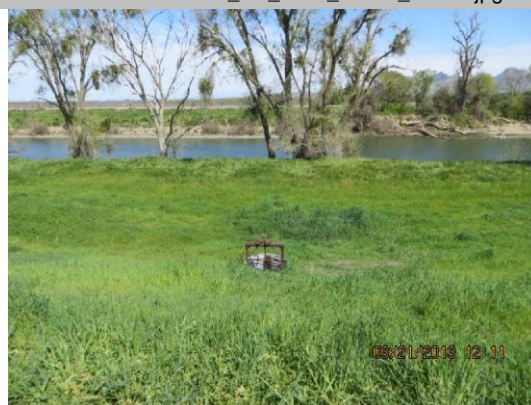
Photo 3 of 3 : UCIP\_SP\_2017\_10536\_17881.jpg

Slide gate in CMP riser on WS toe.

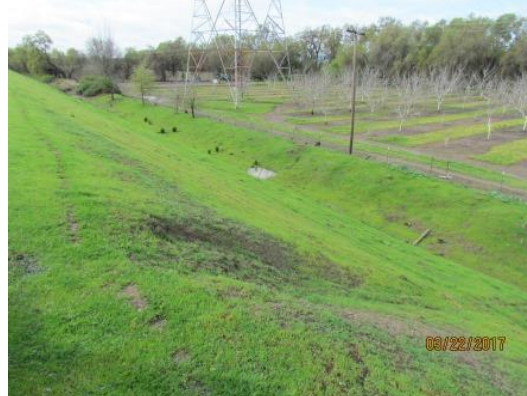
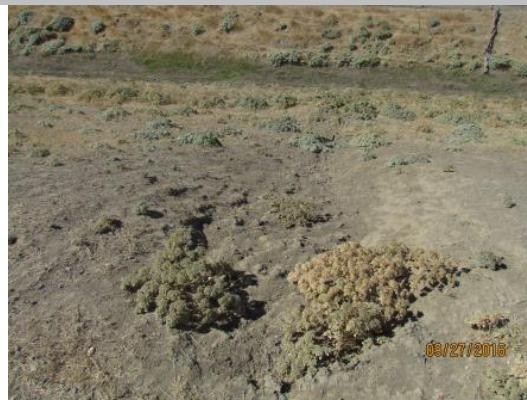
Slope stability issue due to foot traffic. Spring 2017.

Slope stability issue due to foot traffic. Fall 2016 inspection.

| S2 : Repair the levee slope damaged by foot traffic and prevent access where possible. | | | | | |

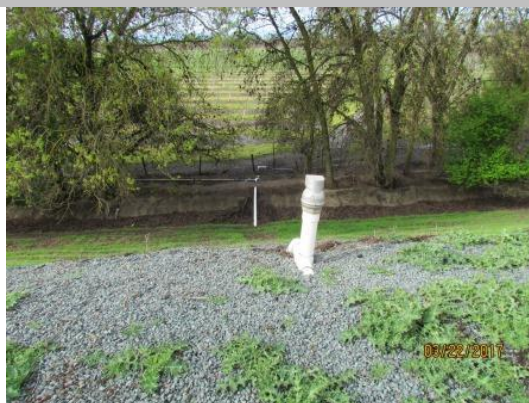
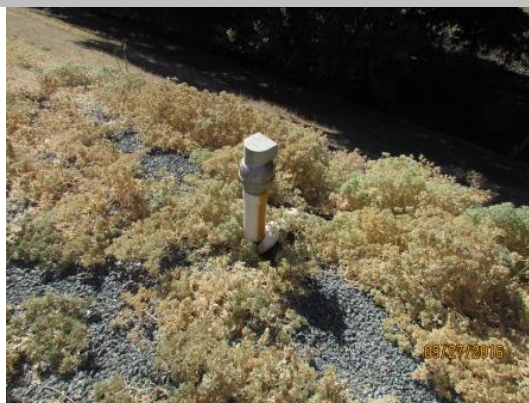
| PVC irrigation pipe a few inches below the crown. Irrigates landscape on waterside if the levee. | | | | | |

Additional view of pipe riser on landside slope near levee crown, and pipe running through levee toe in background. Spring 2017.

View of pipe riser on landside slope near the crown of the levee. Fall 2016 inspection.

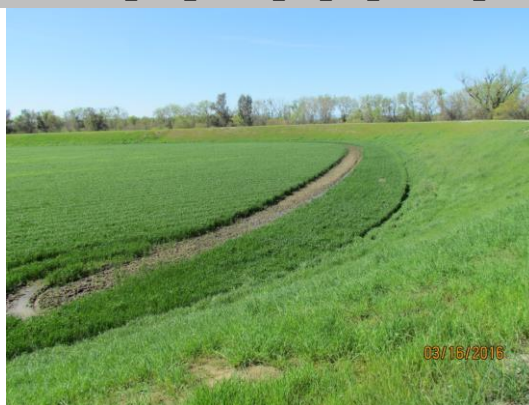
Photo 1 of 1 : SP\_2017\_NA0016\_435\_228\_20170320\_00111.jpg

| Seepage site is being monitored by LMA. | | | | | |

View of the seepage on the landward side of the levee looking upstream. Spring 2016.

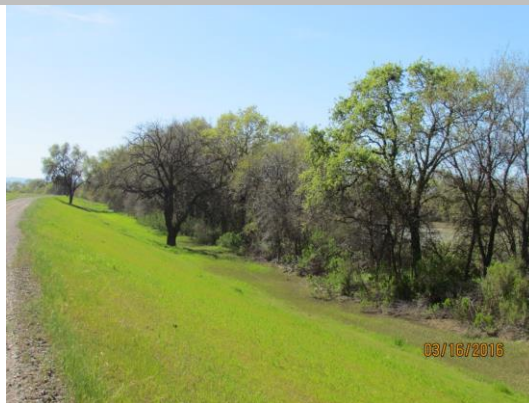
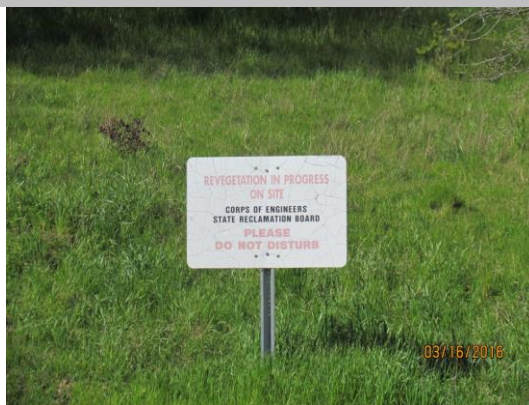
View of the revegetation site on the waterward side of the levee looking upstream. Spring 2016.

Sign stating revegetation site. Spring 2016.

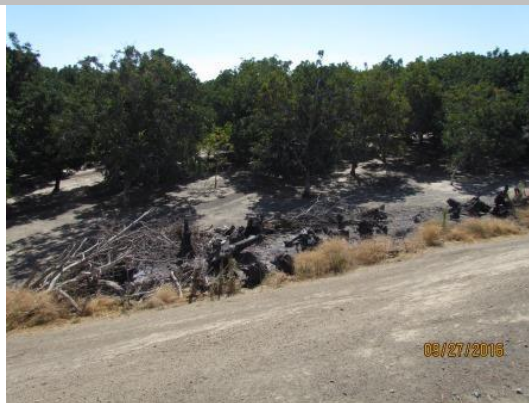
Photo 1 of 1 : SP\_2017\_NA0016\_435\_105\_20170320\_00053.jpg

View of debris within 10 feet of landside toe. Fall 2016 inspection.

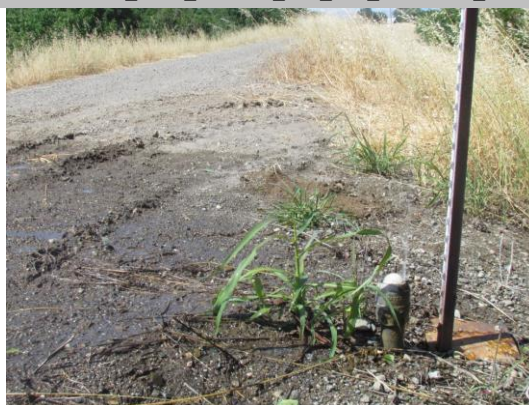
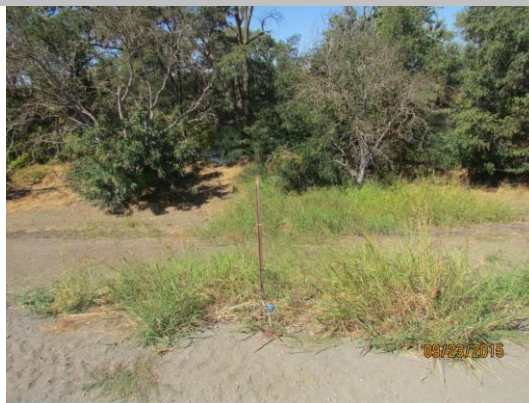
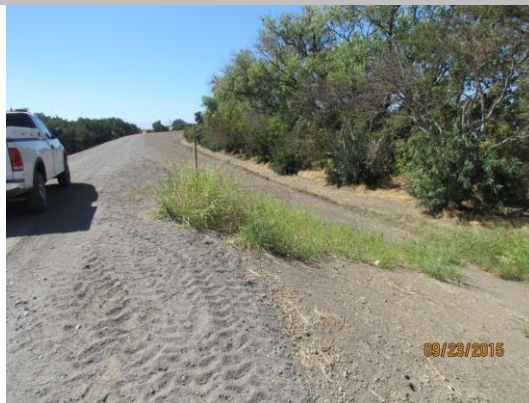
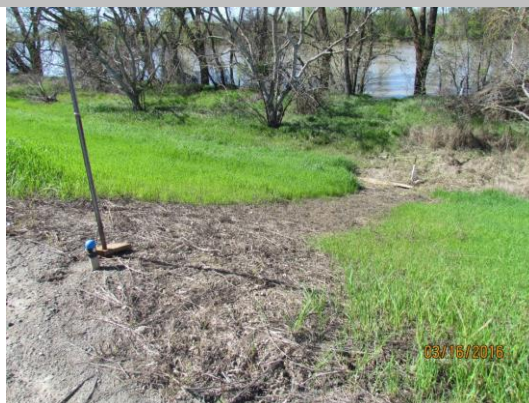
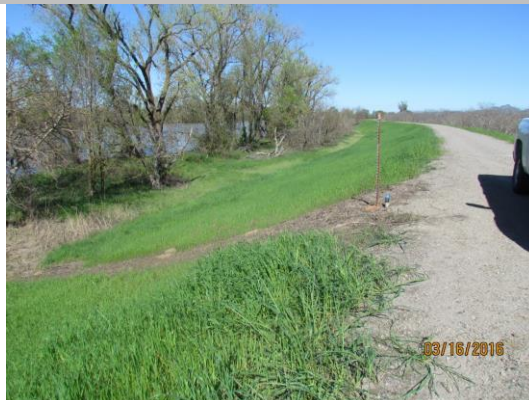
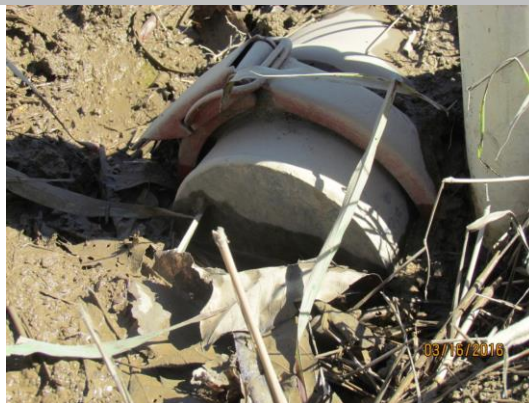
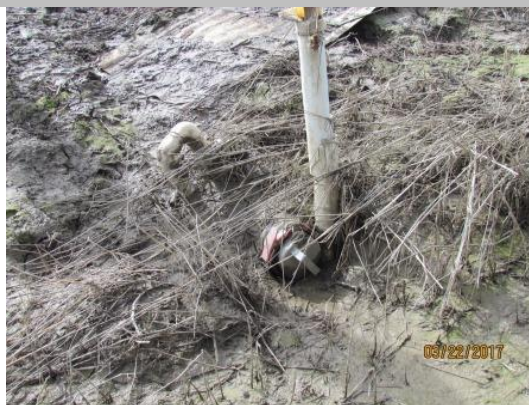
| The siphon filter is fixed. There is no external leak on the levee from the pipe, however there are vegetation growing in line with the pipe. Update 3/16/2016: Seems some maintenance was done on pipe. Vegetation on top of pipe is removed. | | | | | |

View of the siphon breaker on the shoulder of the waterward side of the levee looking upstream. Spring 2015.

Vegetation is aligned where the pipe is on the waterward side of the levee. Fall 2015.

Perspective view of the vegetation where the pipe runs through the levee on the waterward side of the levee looking upstream. Fall 2015.

Non-vegetated seems to align with the pipe. Spring 2016.

Perspective view of the non-vegetated area where the pipe seems to run through the levee looking downstream. Spring 2016.

Pipe seems to be capped off at the toe of the levee on the waterward side of the levee. Spring 2016.

Additional view of pipe cap at waterside levee toe. Spring 2017.

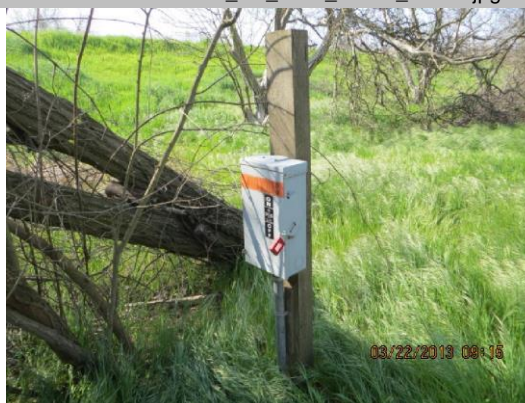
Photo 3 of 3 : UCIP\_SP\_2017\_46812\_17907.jpg

| FS_ID:46812<br>DS_ID:20314<br>EP_NO: 15763<br>Repair Type: Non-Urgent<br>Crossing Status: Found<br>UCIP Comments: Fresno valve on WS shoulder is broken. Pipe appears to be abandoned. Need to abandon properly if necessary. site visit on 10/09/2015 indicates water is present somewhere along the waterside levee slope. Possibly siphon breaker or fresno valve sprays and drains down levee slope from WS shoulder. internal inspection of pipe recommended to determine source of leak. Pipe is active, but can be removed and capped when not in use.<br>FIELD_STRUCT_DESC: 4-inch galvanized steel irrigation pipe through levee 2.0 feet below crown. Irrigation valve approx. 50 feet landward of the landward levee toe. Fresno valve on WS shoulder with connection for pump at WS berm. (Permit No. 15763, 1992).<br>FS Date: 3/22/2013 | | | | | | |

Electrical box at WS berm for portable pump.

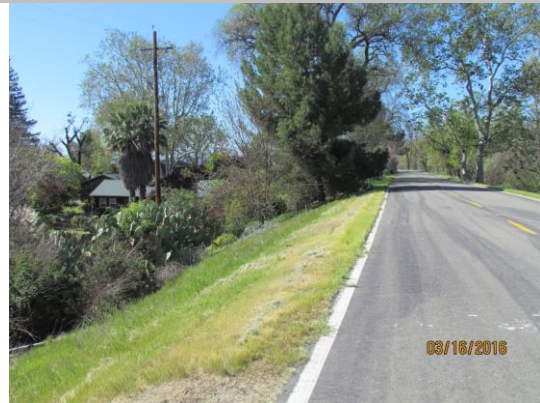
Photo 1 of 1 : SP\_2017\_NA0016\_435\_54\_20170320\_00031.jpg

| Cactus on slope and toe of levee, landscape continues along roadway with fence and stairs. | | | | | |

View of the revegetation on the landward side of the levee looking upstream. Spring 2016.

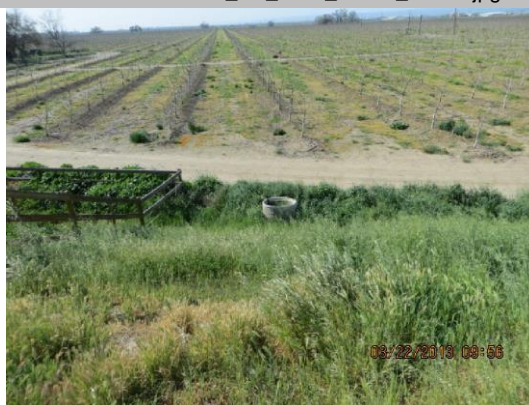
Photo 1 of 1 : UCIP\_SP\_2017\_10553\_17929.jpg

Possible location for pipe crossing.

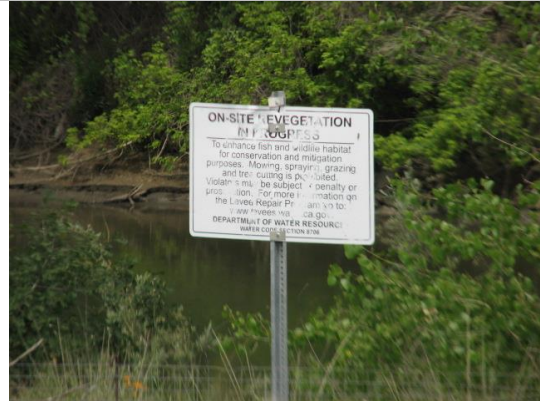
Photo 1 of 1 : SP\_2017\_NA0016\_435\_90\_20170320\_00042.jpg

A revegetation site along the waterside berm. Spring 2014

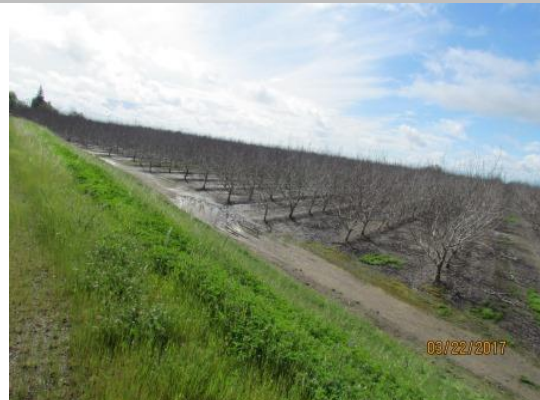
Photo 1 of 1 : SP\_2017\_NA0016\_435\_198\_20170417\_00330.jpg

Historical seepage location at landside levee toe. Spring 2017.

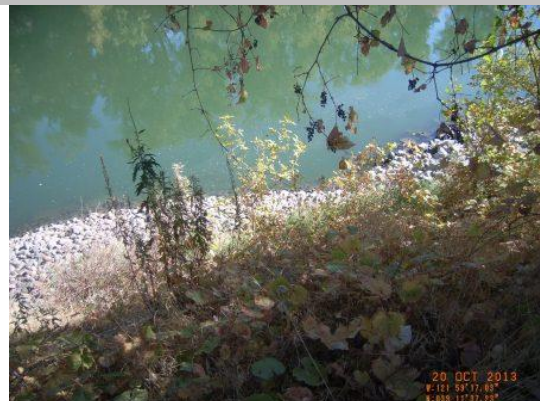
Photo 1 of 1 : SP\_2017\_NA0016\_435\_3\_20170320\_00003.jpg

| 2010 - Old cobble site starting to unravel at toe. 2011 - Cobbles continue to unravel. 2013 - Site extended downstream to revetment. 2015: No observed changes. [2015 Site ID: SAC_141-5_R] | | | | | |

USACE 2013 Photo #1

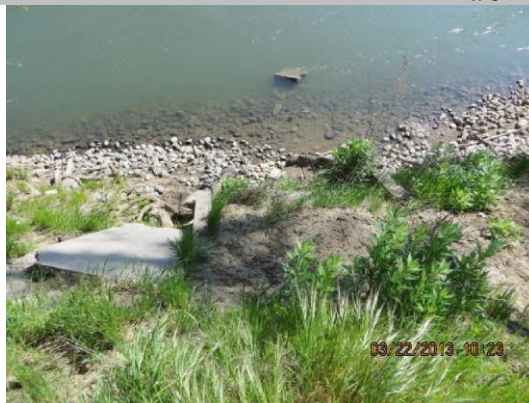
Photo 1 of 2 : UCIP\_SP\_2017\_10563\_17941.jpg

| FS_ID:10563<br>DS_ID:20309<br>EP_NO: 9347<br>Repair Type: Non-Urgent<br>Crossing Status: Indicator Found<br>UCIP Comments: Need to determine type of abandonment.<br>FIELD_STRUCT_DESC: 2 of 2: *Removed*16-inch steel pipe through levee 17.3 feet below crown. Gate valve on the waterward end. Pump on the waterward bank. Switch box on the waterward shoulder. (ABO No. 9347,1960). Originally included in the 1960 O&M manual.<br>FS Date: 3/22/2013 | | | | | |

Concrete pump house debris on WS berm.

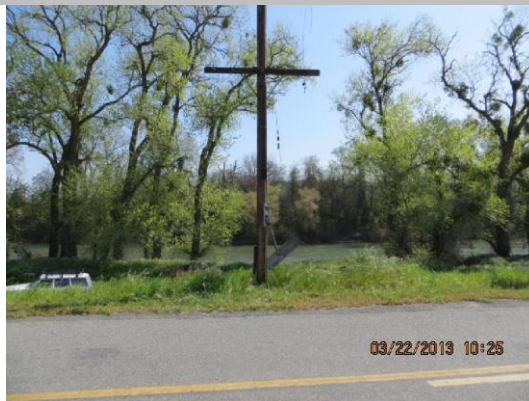
Photo 2 of 2 : UCIP\_SP\_2017\_10563\_17940.jpg

JP on WS shoulder for removed pump switch house.

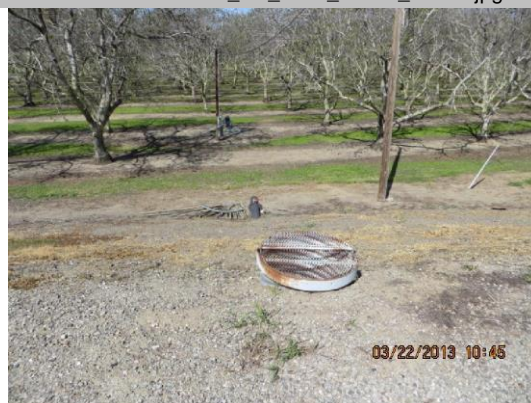
Photo 1 of 3 : UCIP\_SP\_2017\_10566\_17954.jpg

| FS_ID:10566<br>DS_ID:20300<br>EP_NO: 9343<br>Repair Type: Non-Urgent<br>Crossing Status: Found<br>UCIP Comments: Pipe appears to be abandoned. Need to verify type of abandonment.<br>FIELD_STRUCT_DESC: 2 of 2: 24-inch pipe through levee 15.5 feet below crown (pipe measures 12-inch on LS toe). Slant pump on steel piling structure on the waterward bank. Butterfly valve at toe of the landward slope. Overhead power line crosses the levee. (ABO No. 9343, 1960) Originally included in the 1960 O&M manual.<br>FS Date: 3/22/2013 | | | | | |

Siphon Breaker in 30-inch CMP riser on LS shoulder and butterfly valve at LS toe.

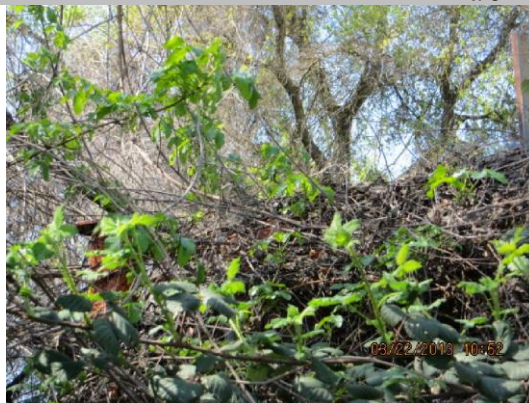
Photo 3 of 3 : UCIP\_SP\_2017\_10566\_17952.jpg

| FS_ID:10566<br>DS_ID:20300<br>EP_NO: 9343<br>Repair Type: Non-Urgent<br>Crossing Status: Found<br>UCIP Comments: Pipe appears to be abandoned. Need to verify type of abandonment.<br>FIELD_STRUCT_DESC: 2 of 2: 24-inch pipe through levee 15.5 feet below crown (pipe measures 12-inch on LS toe). Slant pump on steel piling structure on the waterward bank. Butterfly valve at toe of the landward slope. Overhead power line crosses the levee. (ABO No. 9343, 1960) Originally included in the 1960 O&M manual.<br>FS Date: 3/22/2013 | | | | | | |

Pump on structure covered in brush on WS berm.

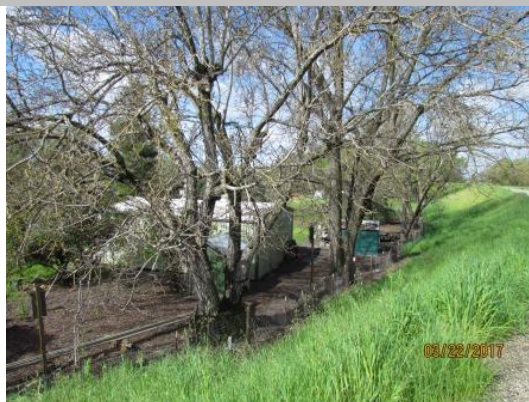
Photo 1 of 1 : SP\_2017\_NA0016\_435\_199\_20170417\_00331.jpg

| Fence along landside levee toe blocking access. | | | | | |

Fence along landside levee toe blocking access. Spring 2017.

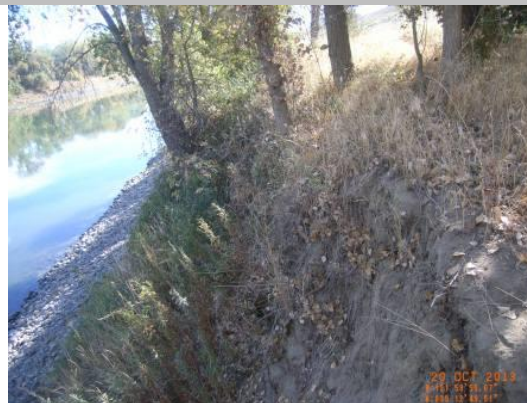
Photo 1 of 1 : SP\_2017\_NA0016\_435\_19\_20170320\_00018.jpg

| 2011 - Multiple scallops, one tree pop out. Old cobble site starting to unravel at midbank. 2012 - Mid bank slumping continues to worsen but cobble at the toe appears stable. 2015: No observed changes. [2015 Site ID: SAC_143-5_R] | | | | | |

USACE 2013 Photo #1
